Our ref: EJM/RLK/14891~03

RE: WAR MEMORIAL, CASTLE HEDDINGHAM, ESSEX

I was pleased to visit the above on 25th October 2013, when I undertook a brief structural assessment of the War Memorial and am pleased to confirm my findings as follows.

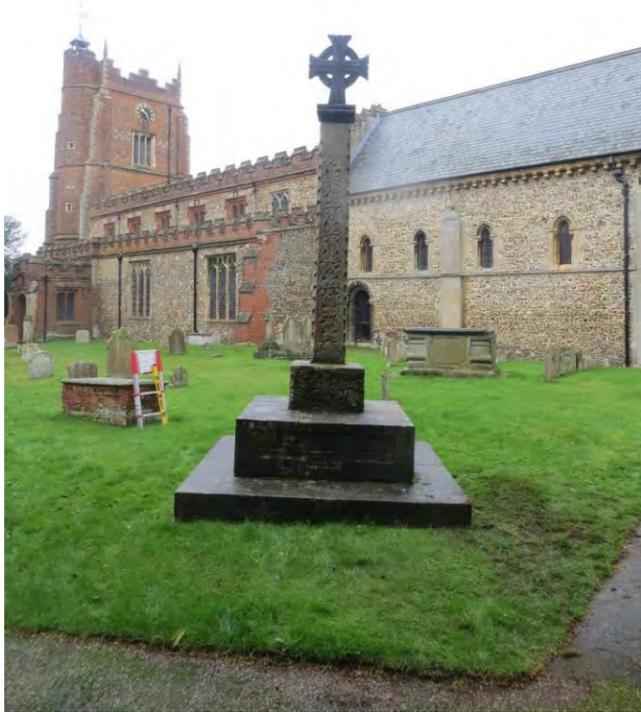
Photograph 1: SE Elevation

The War Memorial dates from 1921 (see photograph 1) and resides to the south east end of the churchyard on a direct access from the gate which leads onto Falcon Square. It is orientated to face towards the gate and thus with the front facing south east. Directional notations are taken in relation to this.

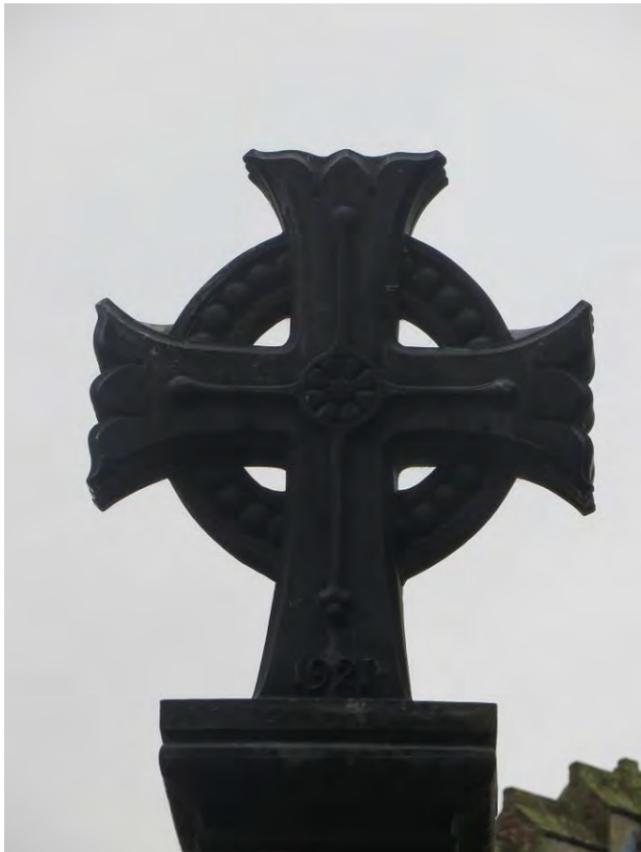
Photograph 5: SE Elevation Lead Cross

The lead cross was briefly inspected from ladder access, although this was limited. The cross can be seen to lean to the SE in its height. It was not possible to establish the nature of the fixing between the cross and shaft head. We assume the lead cross will be hollow and fixed around an armature or possible a solid substrate such as timber (which we have seen elsewhere for lead elements). If timber this may have decayed hence the movement. In either case we consider it will be necessary to carefully release the cross and establish the fixing and constructions details and then re-set back in a vertical position. The actual condition of the lead appears good and thus only limited further works is envisaged.

- Removal of lead cross, checking of construction, minor repairs and installation of new fixing detail;
- Cleaning of memorial following trial sample areas, but assumed to be JOS of DOFF or Thermatec system;
- Re-pointing of all joints to stones and between layers;
- 'Nipping' back of slate course below memorial stone and pointing over.

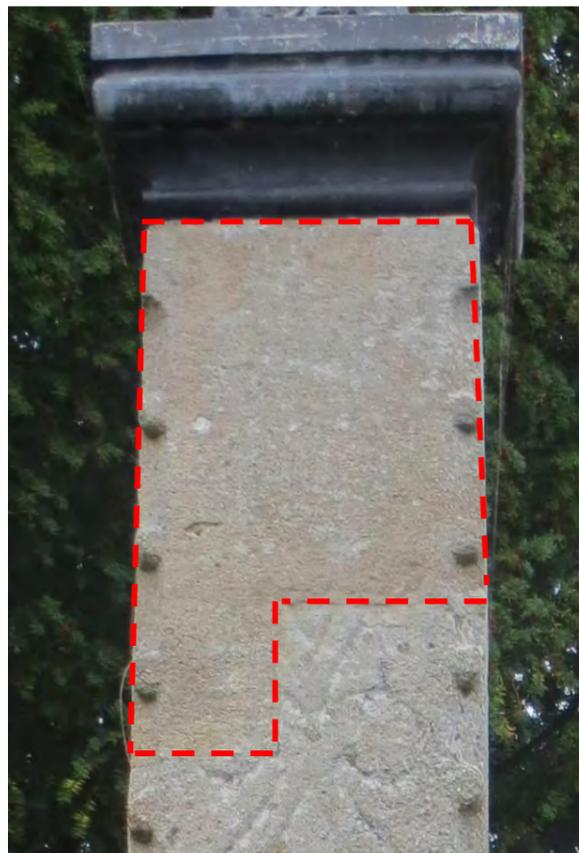
The shaft has clear indications of a new section of stone at the head, which we assume dates to when the memorial was erected. The corners are chamfered to marry with the original stone below, but no attempt has been made to re-carve the motifs to the faces. This accords with good conservation practice where the later repair is readily discernible from the original stone.

Photograph 21: Repair to shaft head

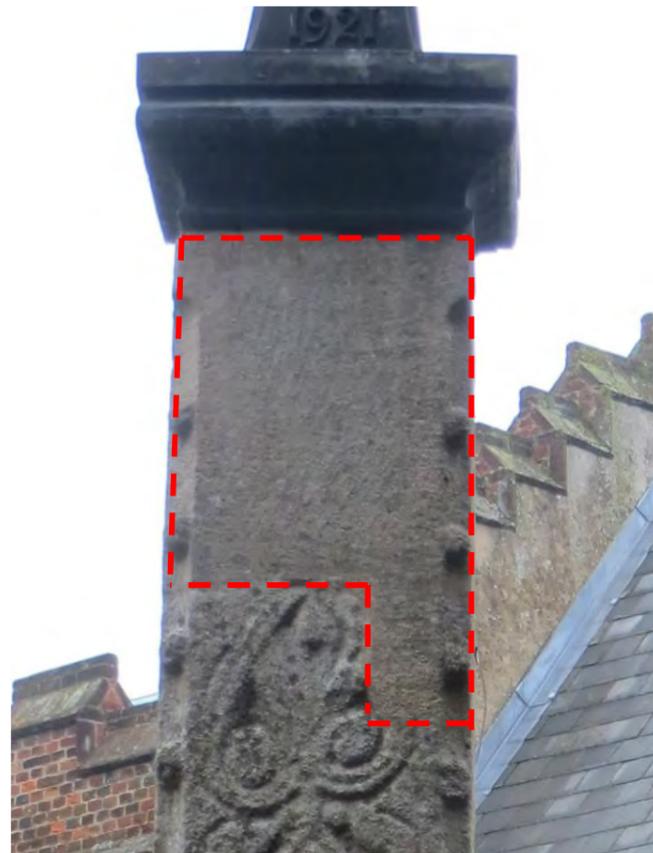
Photograph 22: Repair to shaft head

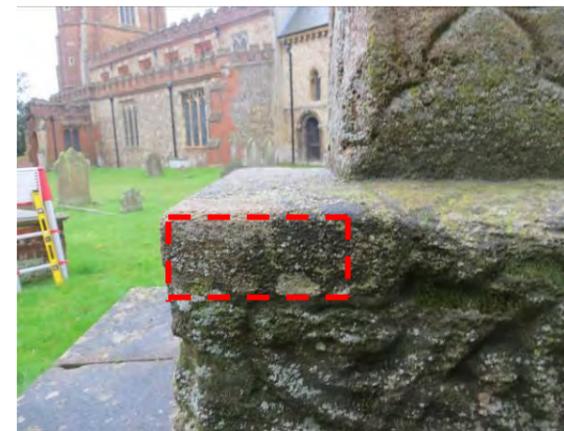
The shaft plinth also has repairs to the top to both the SW and NE sides.

Photograph 23: Repair to shaft base

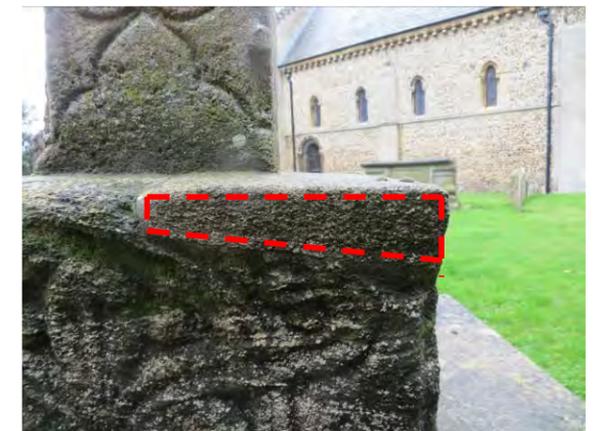
Photograph 24: Repair to shaft base

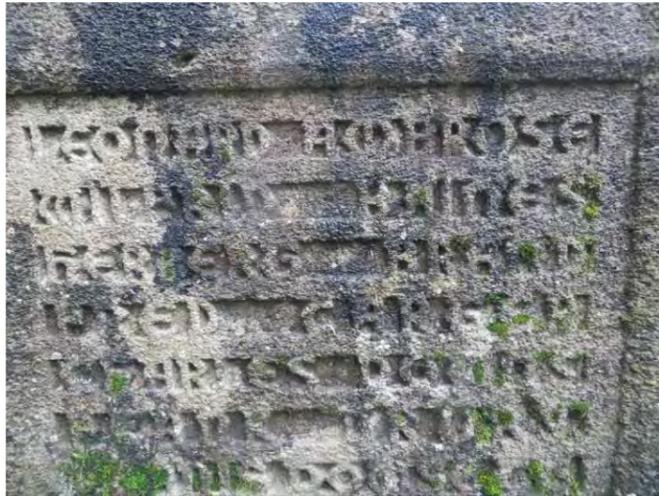
The memorial stone has carved lettering to three sides, with the rear face being blank. The lettering is difficult to decipher and we understand that previous treatment to clean including grit or sand blasting, which possibly caused damage or removed the face of the stone leaving a more vulnerable surface prone to decay. Inside the church is a further memorial to the fallen, and thus the names can be established from this source.

Photograph 25: Eroded script to memorial stone

With regard to the memorial inscription, we do not consider it practical to reinstate the lettering without cutting back and installing a new face. Some improvement may be possible by highlighting with thin pigment washes to the background and odd repairs. However in addition we suggest consideration is given to installing a new cast bronze plaque to the rear face re-recording the names and by reference to the memorial within the church.

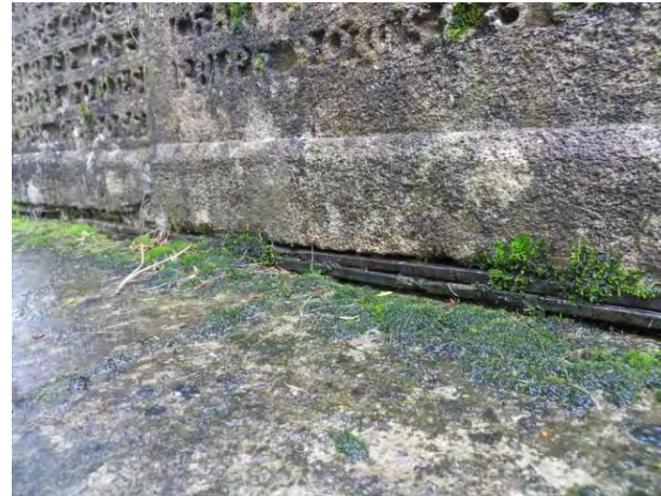
To the underside of the memorial stone between this and this base stone, it was noted that there was a slate packing course. This may have been used as a method of levelling, or perhaps acts as a damp proof course to help reduce the effects of rising damp.

Photograph 26: Slate below memorial stone

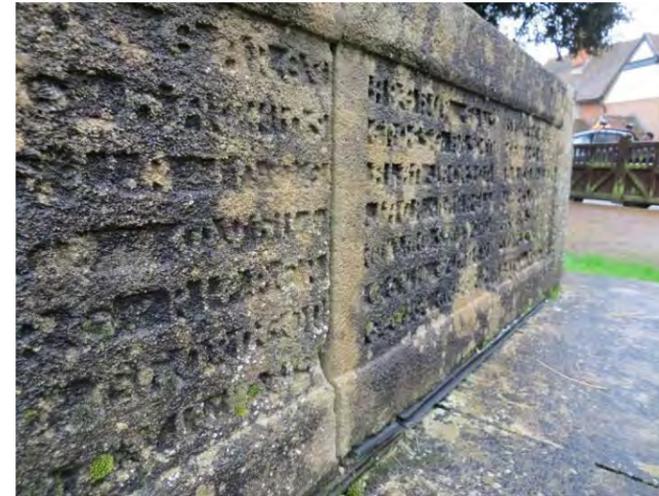
Photograph 27: Memorial stone script

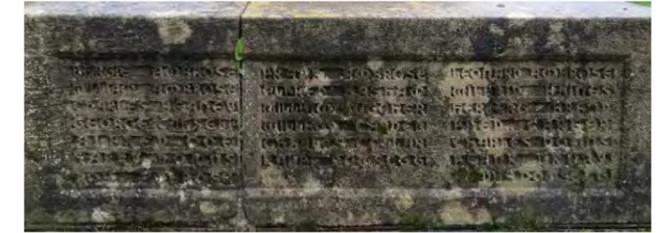
Photograph 28: Memorial stone script
