Our ref: EJM/RLK/14891~03

RE: WAR MEMORIAL, CASTLE HEDDINGHAM, ESSEX

I was pleased to visit the above on 25th October 2013, when I undertook a brief structural assessment of the War Memorial and am pleased to confirm my findings as follows.

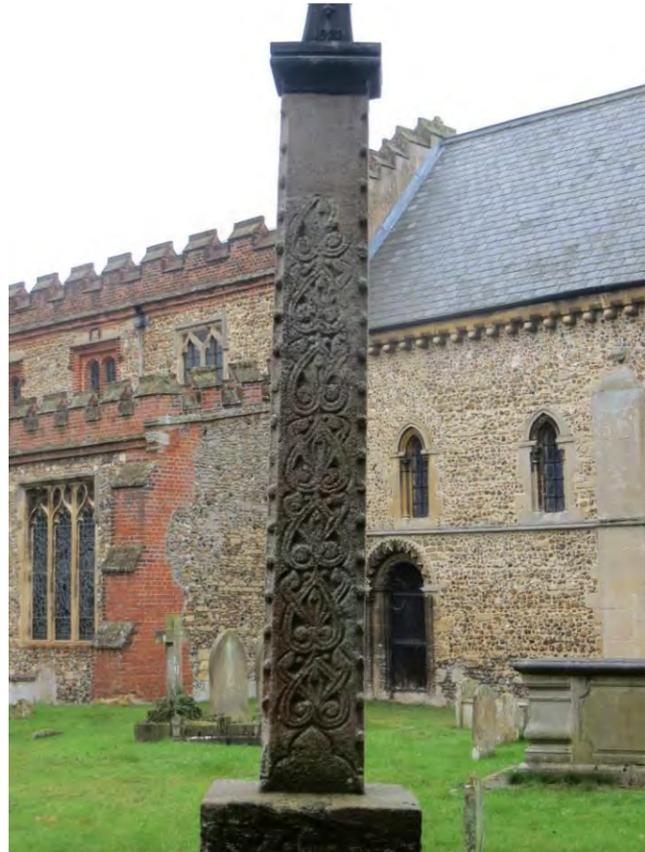
Photograph 5: SE Elevation Lead Cross

The lead cross was briefly inspected from ladder access, although this was limited. The cross can be seen to lean to the SE in its height. It was not possible to establish the nature of the fixing between the cross and shaft head. We assume the lead cross will be hollow and fixed around an armature or possible a solid substrate such as timber (which we have seen elsewhere for lead elements). If timber this may have decayed hence the movement. In either case we consider it will be necessary to carefully release the cross and establish the fixing and constructions details and then re-set back in a vertical position. The actual condition of the lead appears good and thus only limited further works is envisaged.

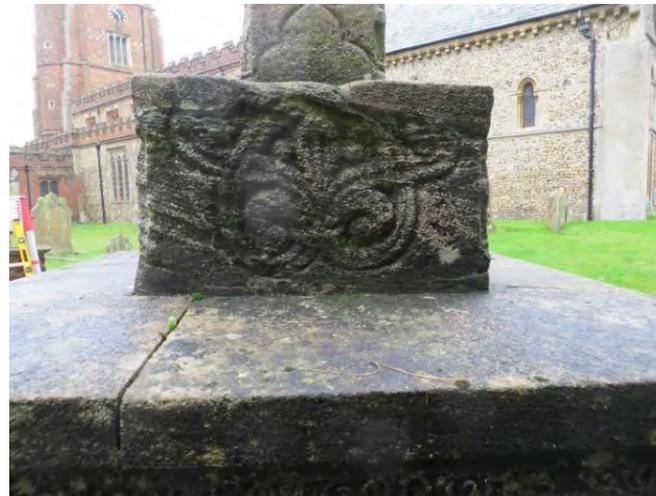
Photograph 6: SE Elevation Shaft

The shaft has clear indications of a new section of stone at the head, which we assume dates to when the memorial was erected. The corners are chamfered to marry with the original stone below, but no attempt has been made to re-carve the motifs to the faces. This accords with good conservation practice where the later repair is readily discernible from the original stone.

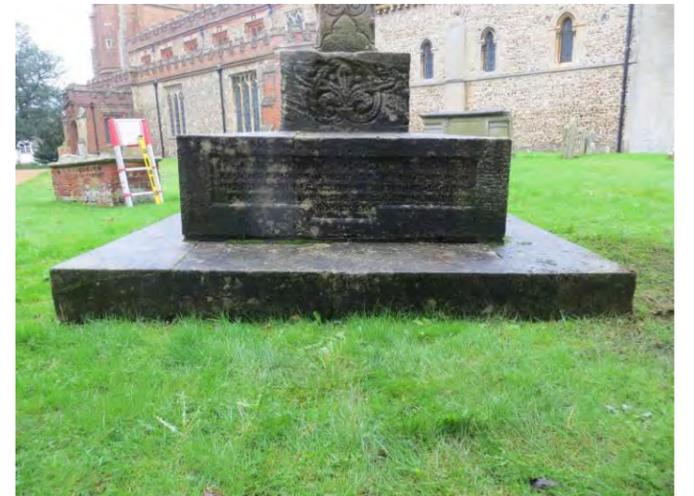
Photograph 7: SE Elevation Shaft plinth

The shaft plinth also has repairs to the top to both the SW and NE sides.
